ENGINEERED LONG RANGE MODERNIZATION PROGRAM

PHASE II REPORT

SAN FRANCISCO BAY NAVAL SHIPYARD

Report No. 67-12-RE
October 1967

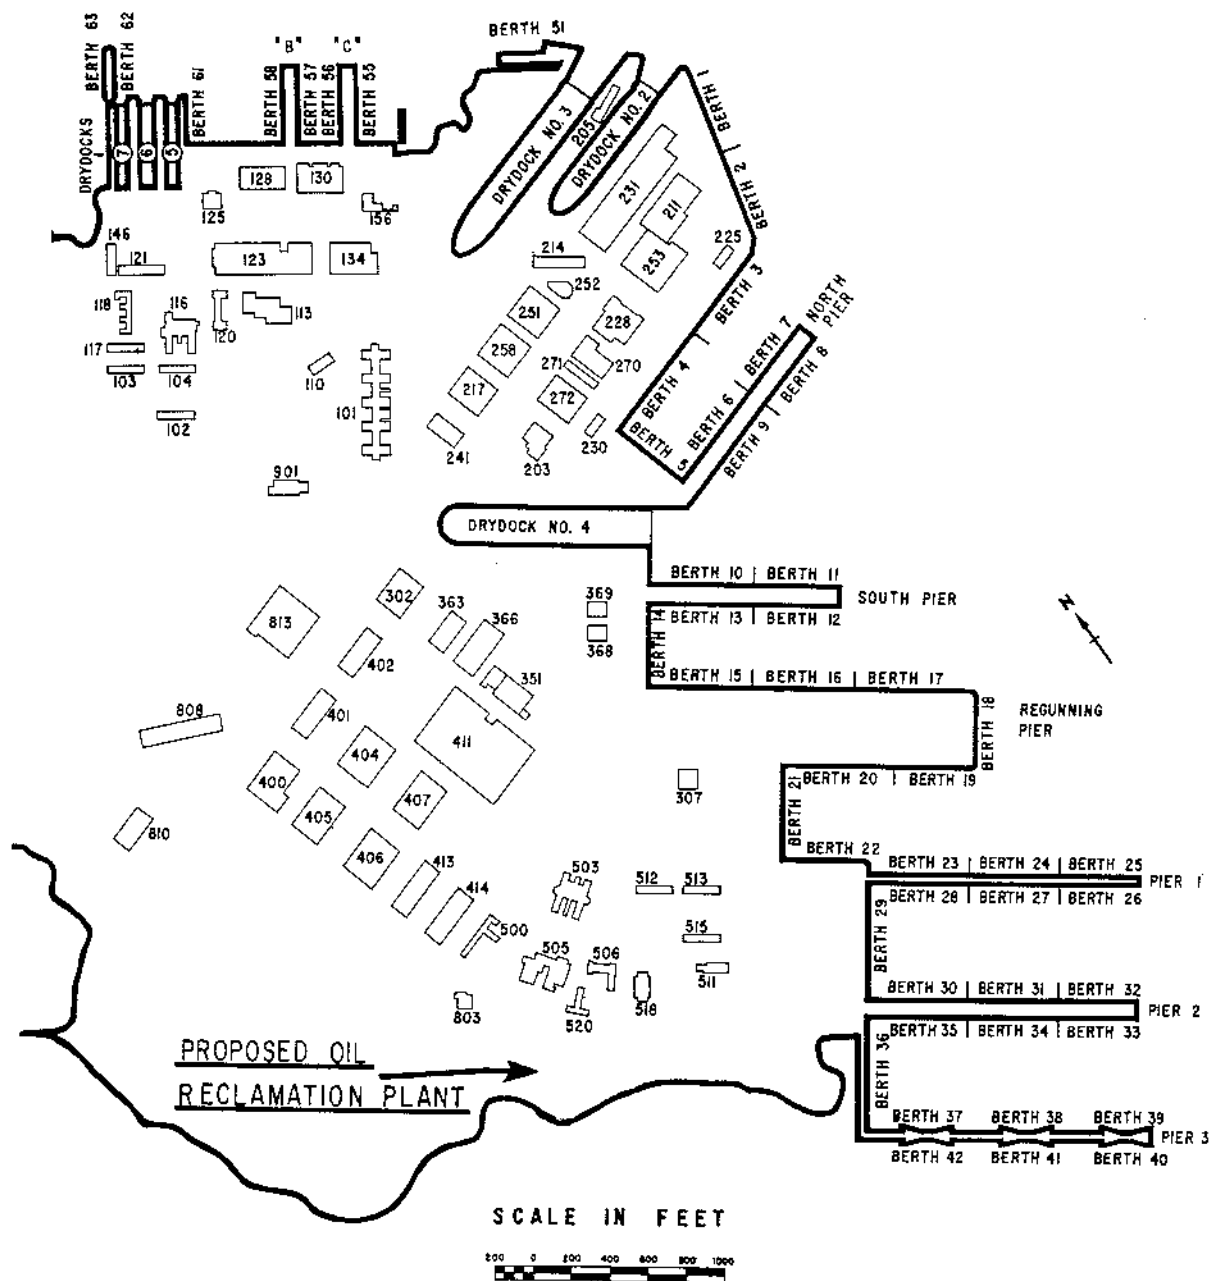
FIGURE VI-4
 SAN FRANCISCO BAY NAVAL SHIPYARD
 HUNTERS POINT SITE
OIL RECLAMATION SYSTEM
 PROPOSED MODERNIZATION PLAN

- Oil leaches through the system dikes into the bay in violation of local anti-pollution regulations.
- The water that is pumped into the bay from the lakes contains oil in excess of the 20 mg/liter limitation set by local regulations. Furthermore, during heavy rains the level of the open ponds rises at a rate which exceeds the rate at which the existing pumps can dispose of the water. Consequently the surface oil in the ponds overflows into the bay.

Recommendations call for steam treatment facilities and are formulated as MCON P-155, FY 1, in the amount of \$89,000 (see Appendix A to this volume of the report). These recommendations include the following:

- Installation of dual-purpose transfer pumps to put a suction on the existing eight-in. receiving line from Berth 29 to the plant and to discharge processed water to sewer connections.
- Replacement of the 2,400 ft long oil transfer line from Berth 29 to the reclamation plant with new piping.

The location of the proposed oil reclamation plant is depicted in Figure VI-4.

The proposed new oil reclamation plant, with its increased capacity, will eliminate the bay water pollution problems created by the present system, and will have the capacity to handle the projected workloads. Moreover, this new system can easily be adapted to accommodate additional chemical treatment units, as and when required by future anti-pollution regulations.
